Agenda Item: RCTA 9
Presented by: Chile
Original: Spanish

Participation of the Chilean Air and Maritime Search and Rescue Centres in the rescue of the Passenger Ship the Explorer and environmental mitigation of the accident in the Antarctic

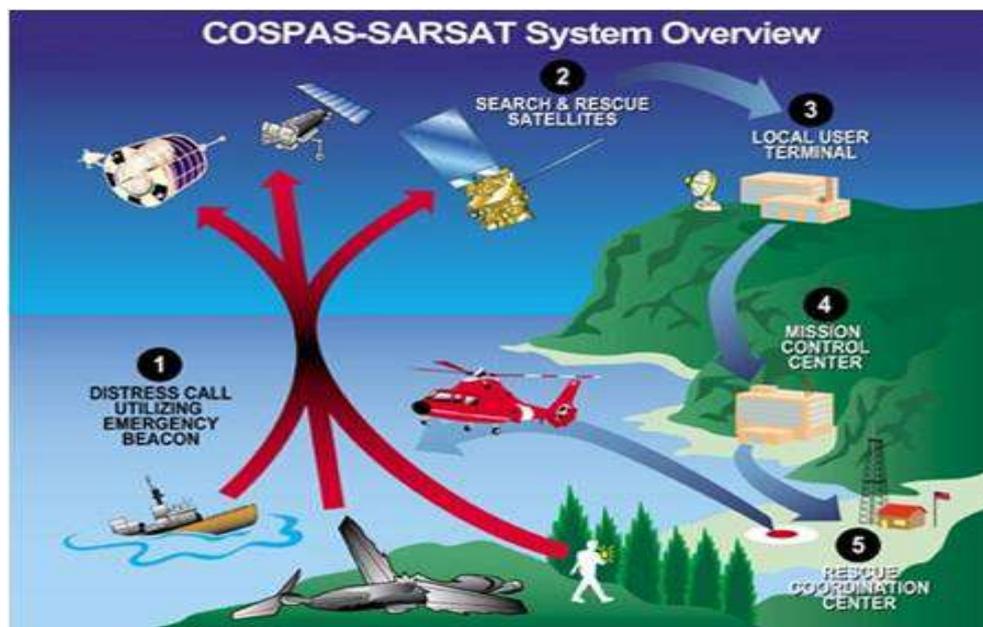
The diagram below shows how the Satellite Assistance System works

Overview of COSPAS-SARSAT Satellite Assistance System

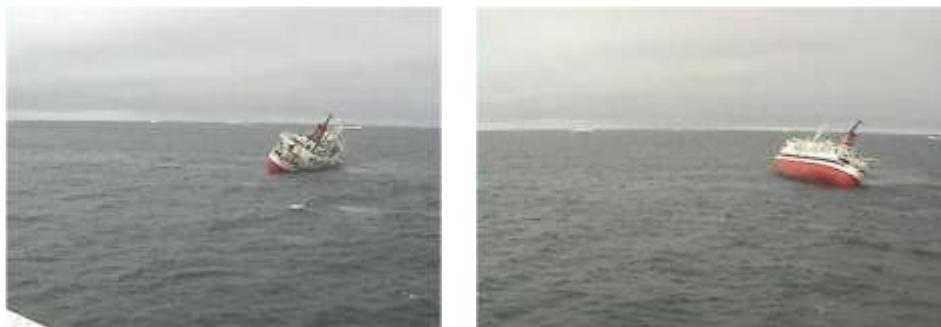
On Friday 23 November, at 00:34 local time in Chile (UTC+3), the Maritime Telecommunications Centre of Valparaíso received a mayday call over HF frequency from MS Explorer, a Liberian-registered ship, briefly informing that it was taking on water having collided with an iceberg. The incident had occurred 44 miles SE of King George Island, in Antarctic waters. The Search and Rescue Service of Chile (MRCC CHILE) was dispatched to aid the vessel and its crew.

The photos below show MS Explorer prior to sinking.

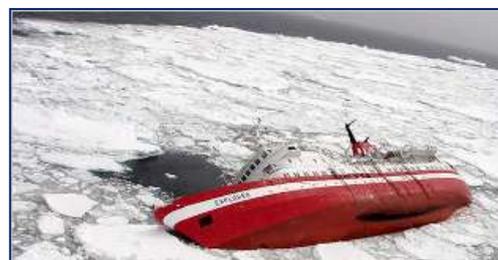
At approximately 12:30 on 24 November, the Icebreaker Viel arrived on the scene of the accident and began monitoring the stricken vessel and the possible pollution. MS Explorer sank at around 15:30 to 1300 m depth, with 185 m³ of diesel, 24 m³ of lubricant and 1.2 m³ of petrol in its tanks. Below are some photos both of the crew in the lifeboats, and also of the sinking of the Explorer

The images that went round the world as the passenger ship the Explorer sank on 23 November 2007

Due to the geographical sinking position of MS Explorer and the adverse meteorological conditions in the area, it was not possible to contain the fuel spill with either rigid or absorbent barriers.

In order to tackle the pollution, the Viel icebreaker proceeded to move through the sea lane over the spill so as to create mechanical dispersion and speed up the weathering process of the spilt fuel, which was primarily Diesel Marine Fuel Oil (D.M.F.O.).
